Typical damages of the polyhedral void reinforced concrete poles for yard overhead transmission lines

***Abstract.** Typical damages of polyhedral void reinforced concrete poles described in the article. The damages found during the inspection of yard overhead transmission lines. Recommendations to minimize the impact of the identified damage the safe operation of concrete poles are the conclusions of the article.*

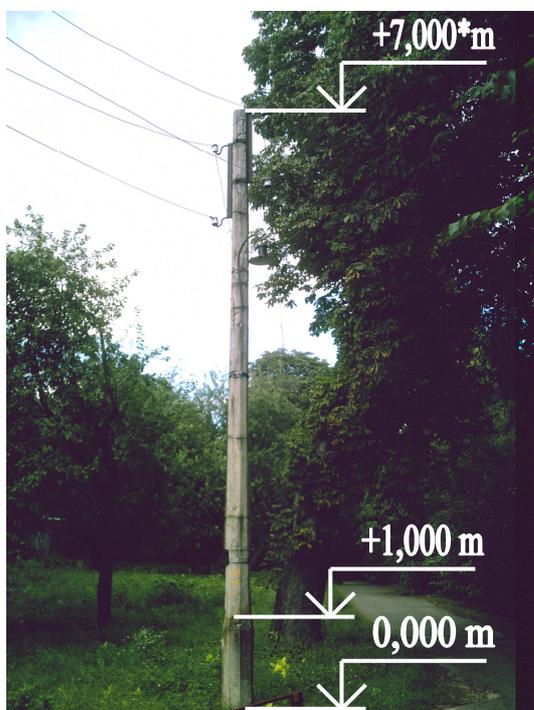
Test results. Surveyed concrete poles have the the following design solution [5]. Rack made conical with a total length 8500 mm. The height of the reinforced concrete poles from the ground level is around 7000 mm. The lower part of the rack at height of 1000 mm from ground level has a local increase in diameter. The cross section of poles has a form of proper octagon with an outer diameter at the lower bulge 335 mm; diameter at mark 1.000 m equal to 270 mm; diameter at mark. + 7,000 meters - 150 mm. Inside the poles are void. Thus the column wall thickness equal to 70-80 mm. Reinforcement of reinforced concrete poles made of eight rods $\varnothing 14$ mm class A400C. Transverse reinforcement - $\varnothing 4$ mm class A240C (step 150 ... 200 mm). General view of the reinforced concrete poles shown in figure 1.

Figure 1 - General view of the reinforced concrete poles

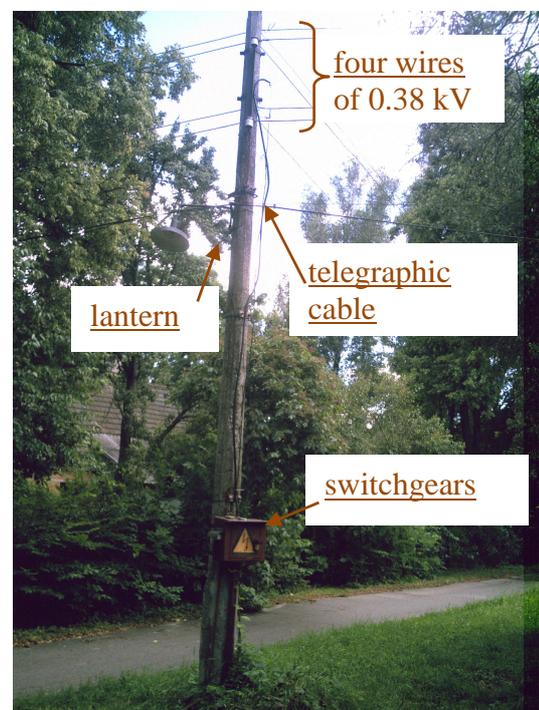
Surveyed concrete poles serve several functions (see. fig. 2):

1. The suspension of four wires of 0.38 kV overhead lines;
2. Suspension of telegraphic cable;
3. Arrangement of street lighting: installation of distribution switchgears and street lighting lantern.

Figure 2 - The functions that perform concrete poles

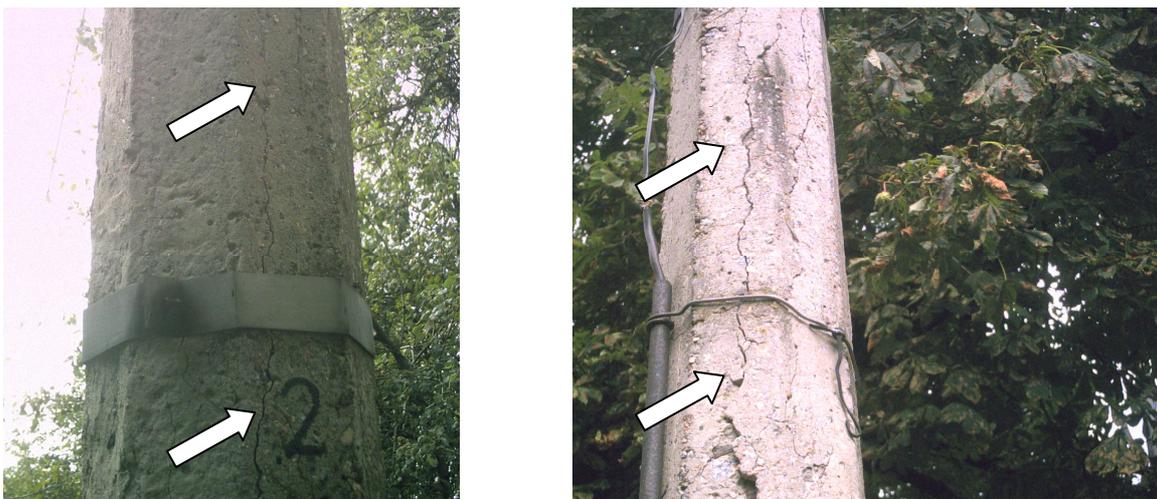
1) The formation of vertical cracks with opening width from 0,5 mm to 4 mm along the reinforcing rods of reinforced concrete poles (fig. 3), arising, probably as a result of penetration of moisture into the hollow of poles and its periodic freezing-thawing. The length of the fixed vertical cracks varies for different poles of reinforced concrete from 0.5 m to 4.5 m, ie almost the entire height of poles.

Figure 3 - Vertical cracks along the reinforcing rods of reinforced concrete poles

On the basis of a number of surveys of reinforced concrete poles of yard power line and the analysis of identified damages can be done the next **conclusions**. The destruction of void reinforced concrete poles occurs due to regular atmospheric moisture, especially at internal closed space and the subsequent freezing-thawing cycles. First, the formation of vertical cracks, then outcrop of working reinforcing rods, local destruction and loss of certain parts of the concrete poles.

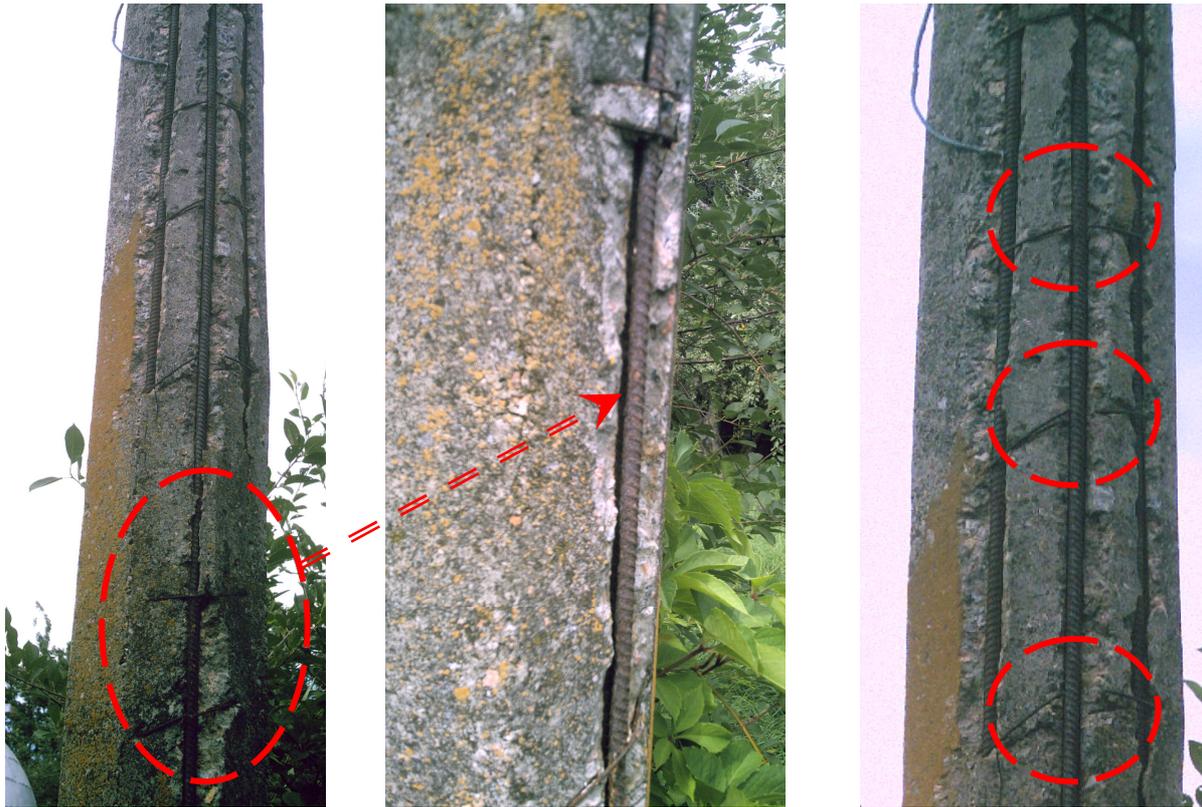
2) As a result of the formation of vertical cracks and mechanical damages of the protective layer of concrete occurs the outcrop of reinforcing rods in reinforced poles (fig. 4). In some places there is complete debonding between reinforced concrete and reinforcing rods, causing the loss of local resistance of these rods.

3) After outcrop of reinforcing rods in reinforced concrete poles occurs development of corrosion on these rods (fig. 4). Corrosion of individual rods of working reinforcement $\text{Ø}14$ mm class A400C reaches 35%. Also fixed gap of transverse reinforcement, made with wire $\text{Ø}4$ mm class A240C reinforced concrete poles.

Figure 4 - Outcrop and corrosion of reinforcing rods of reinforced concrete poles. The gap of transverse reinforcement wire of concrete poles

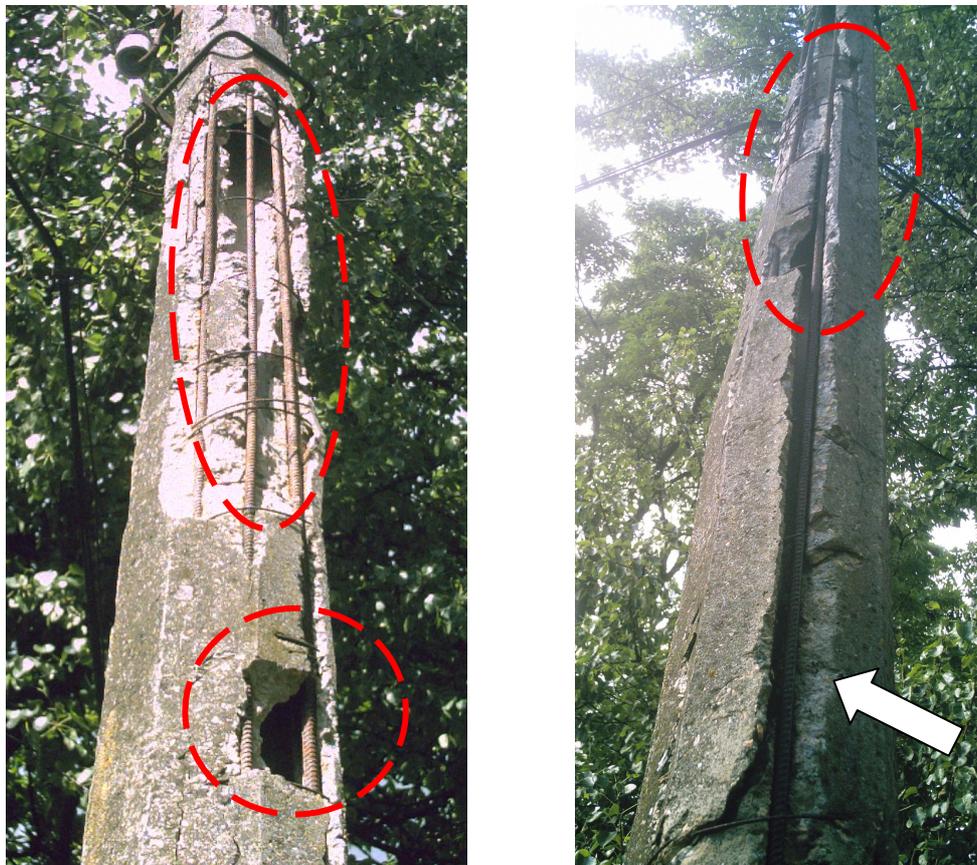
4) As a result of penetration of moisture into emptiness inside reinforced concrete poles and repeating cycles of freezing-thawing occurs cracking, local destruction and loss of individual parts of the concrete poles at a height of 3000 mm (fig. 5). For some concrete poles fixed the destruction of more than half the cross-section of these poles.

Figure 5 - Complete destruction and loss of concrete poles of reinforced concrete parts

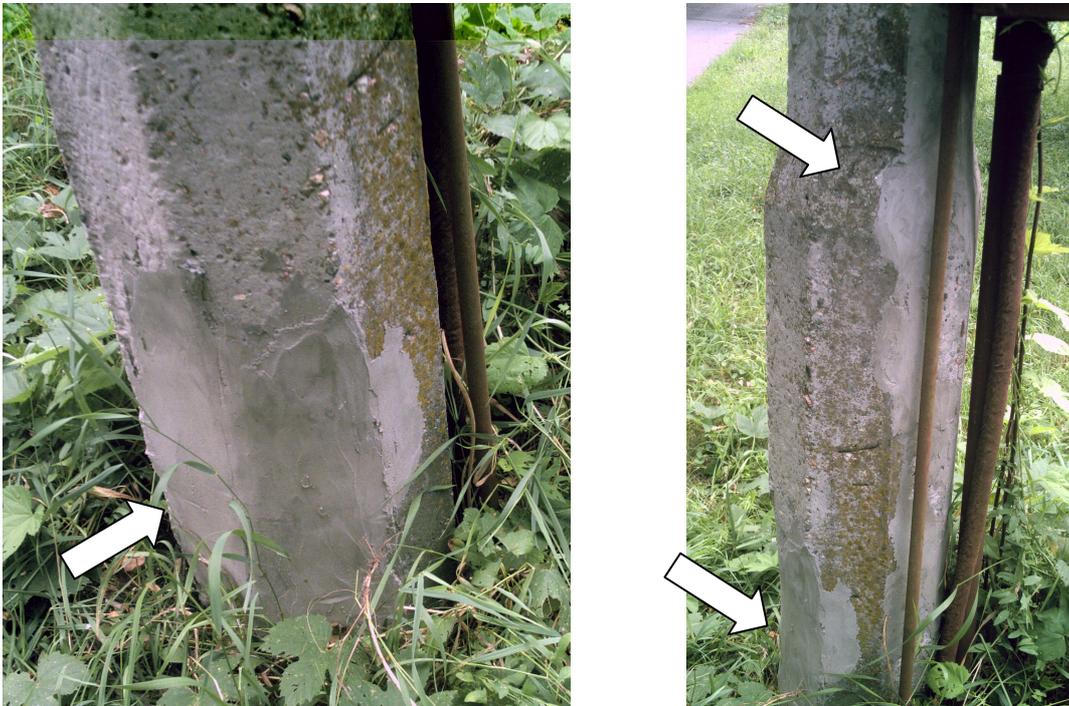
On some concrete poles seen partial periodic repairs of poles (see. fig. 6). During these repairs was carried out filling in damaged areas poles at mark. 0,000 of 1,000 m cement-sand mortar. Previous anticorrosive processing reinforcing rods poles was not fulfilled, which did not provide long-term adhesion of reinforcing rods with the recovered parts of the concrete.

Figure 6 - Partial periodic repairs of some reinforced concrete poles
